**AVALIAÇÃO DE ECOSSISTEMAS AQUÁTICOS ATINGIDOS PELA LAMA  
DE REJEITO DO COLAPSO DA BARRAGEM DE FUNDÃO, MARIANA-MG:  
UMA PERSPECTIVA VIA SENSORIAMENTO REMOTO**

**AN ASSESSMENT OF AQUATIC ECOSYSTEMS AFFECTED BY THE  
FUNDAO TAILINGS DAM COLLAPSE, MARIANA-MG: A PERSPECTIVE BY  
REMOTE SENSING**

TESE APRESENTADA AO INSTITUTO DE  
GEOCIÊNCIAS DA UNIVERSIDADE ESTADUAL  
DE CAMPINAS PARA OBTENÇÃO DO TÍTULO DE  
DOUTORA EM CIÊNCIAS NA ÁREA DE  
GEOLOGIA E RECURSOS NATURAIS

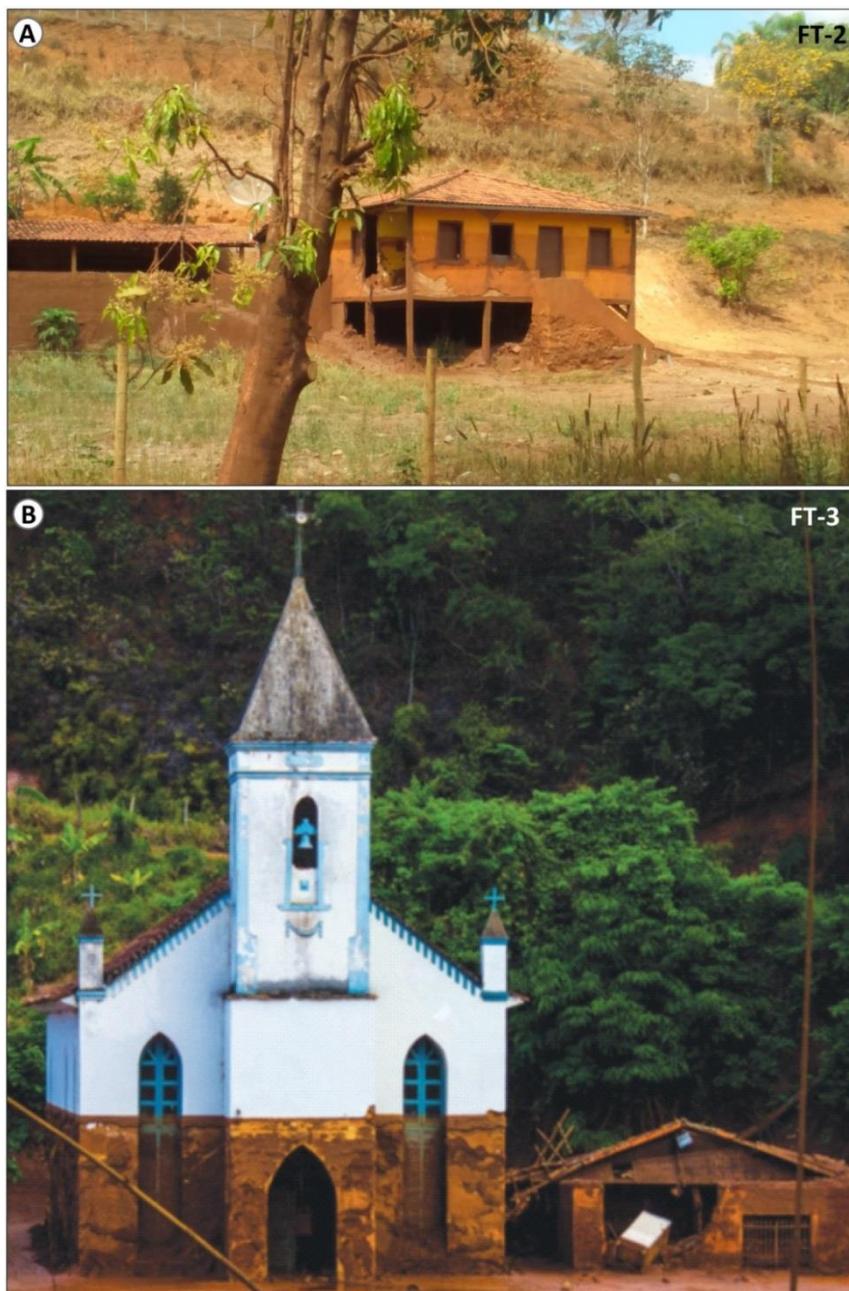
**Fig.7.** (A) FT-2 (setembro, 2016): Residência em zona rural destruída pela avalanche de lama na região de Paracatu de baixoFonte: Acervo pessoal. (B) FT-3: Exemplo de dano ao patrimônio cultural: capela de Barra Longa. Fonte: Sánchez et al. (2019).

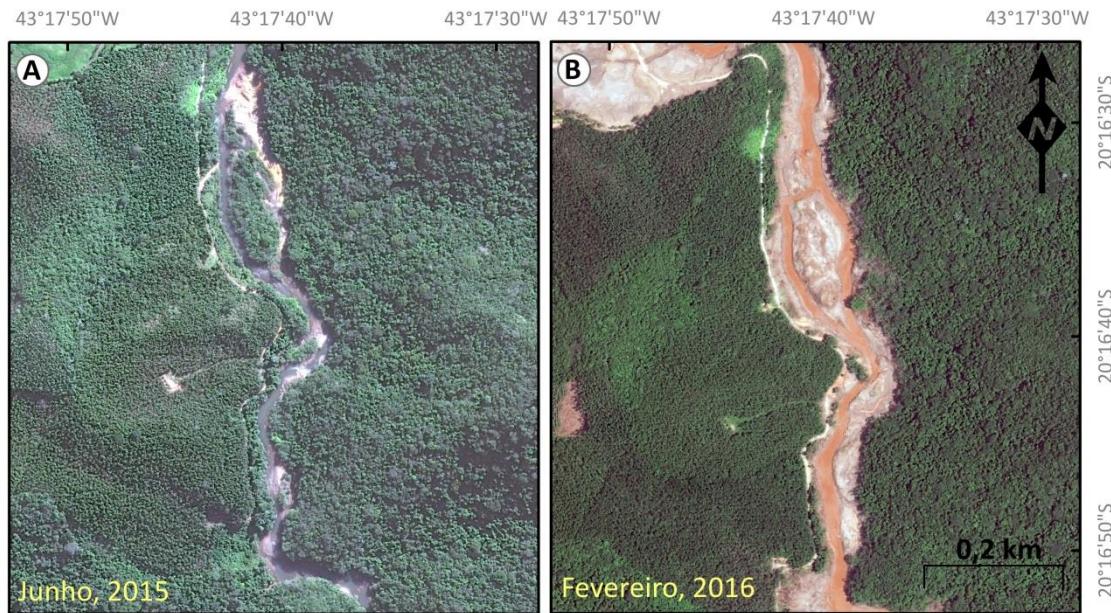
**Fig.8.** Composição colorida cor real obtida com dados do sensor orbital WorldView-3 (RGB123) de um trecho do rio Doce, entre Bento Rodrigues e Paracatú de Baixo, mostrando uma área de preservação ambiental que sofreu a devastação de toda mata ciliar após o colapso. (A) Junho de 2015. (B) Fevereiro de 2016.

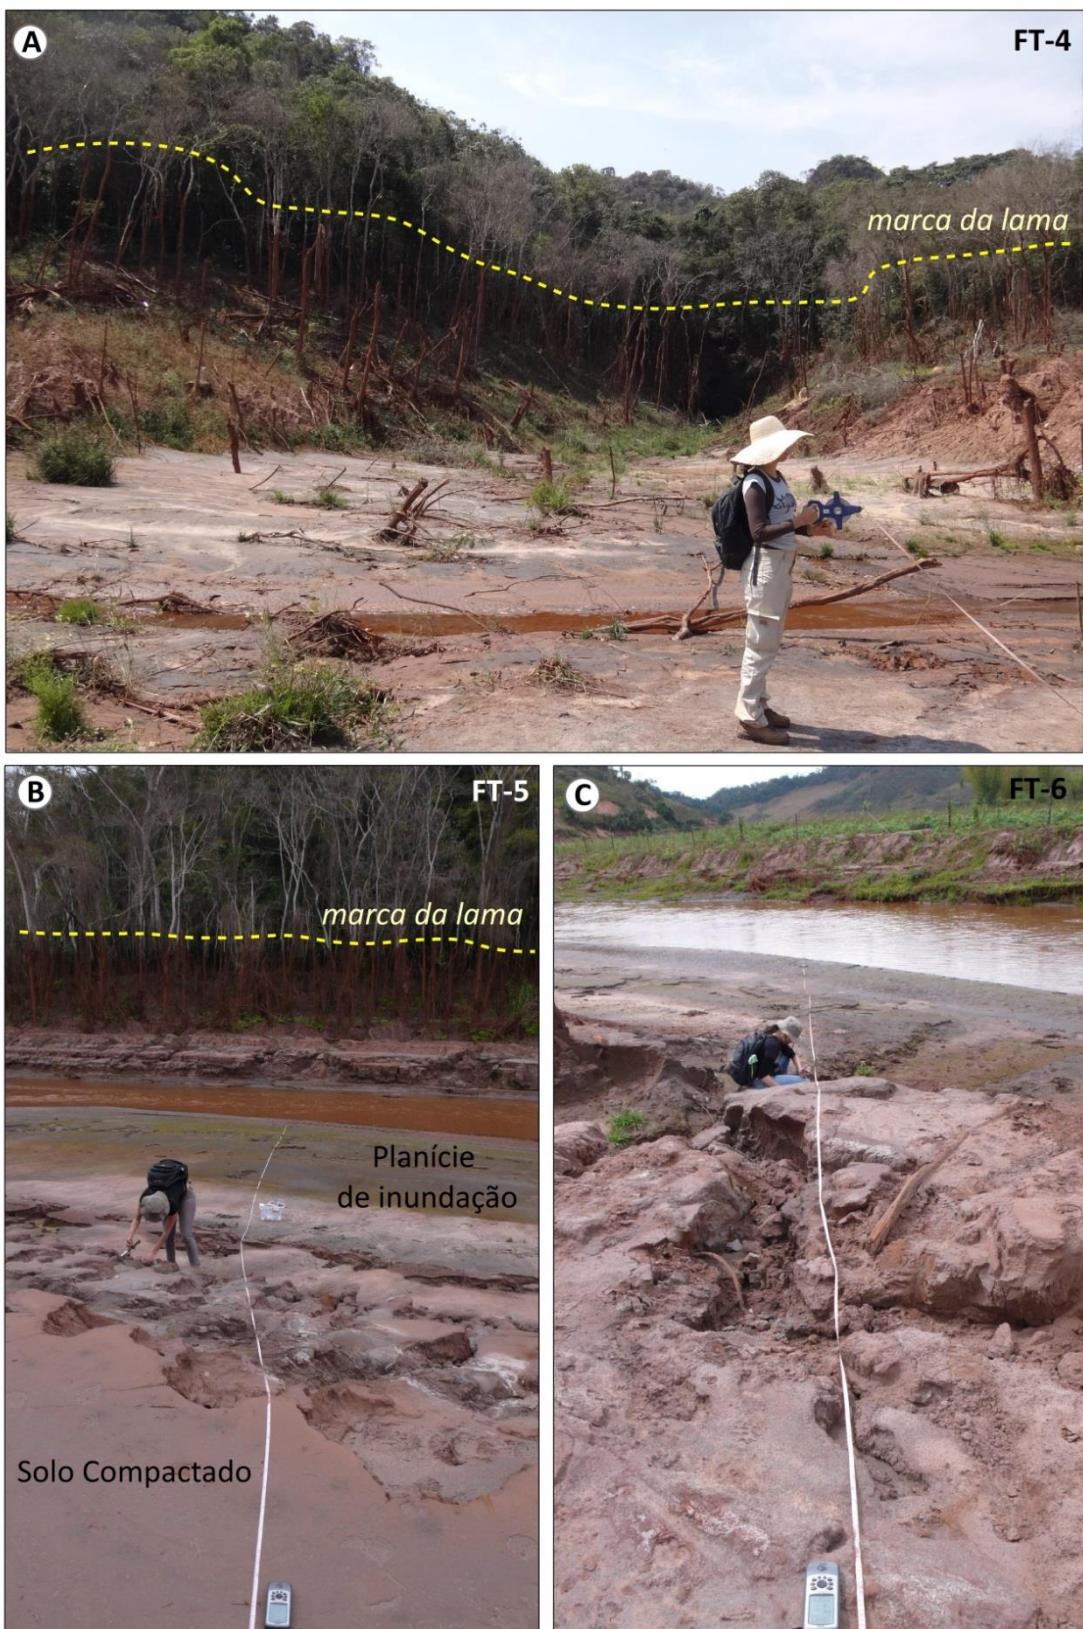
**Fig.9.** Áreas atingidas pela lama mostrando os danos ao solo e à vegetação. (A) Região de Bento Rodrigues, onde a avalanche arrancou grande volume de árvores. (B e C) Margens do rio Gualaxo do Norte, na região de Paracatu de Baixo. Ressalta-se o solo compactado com ausência de vegetação e matéria orgânica, além de locais caracterizados por ravinas e sulcos erosivos. Fotos FT-4 a FT-6 obtidas no dia 14 de setembro de 2016 (Fonte: Acervo pessoal).

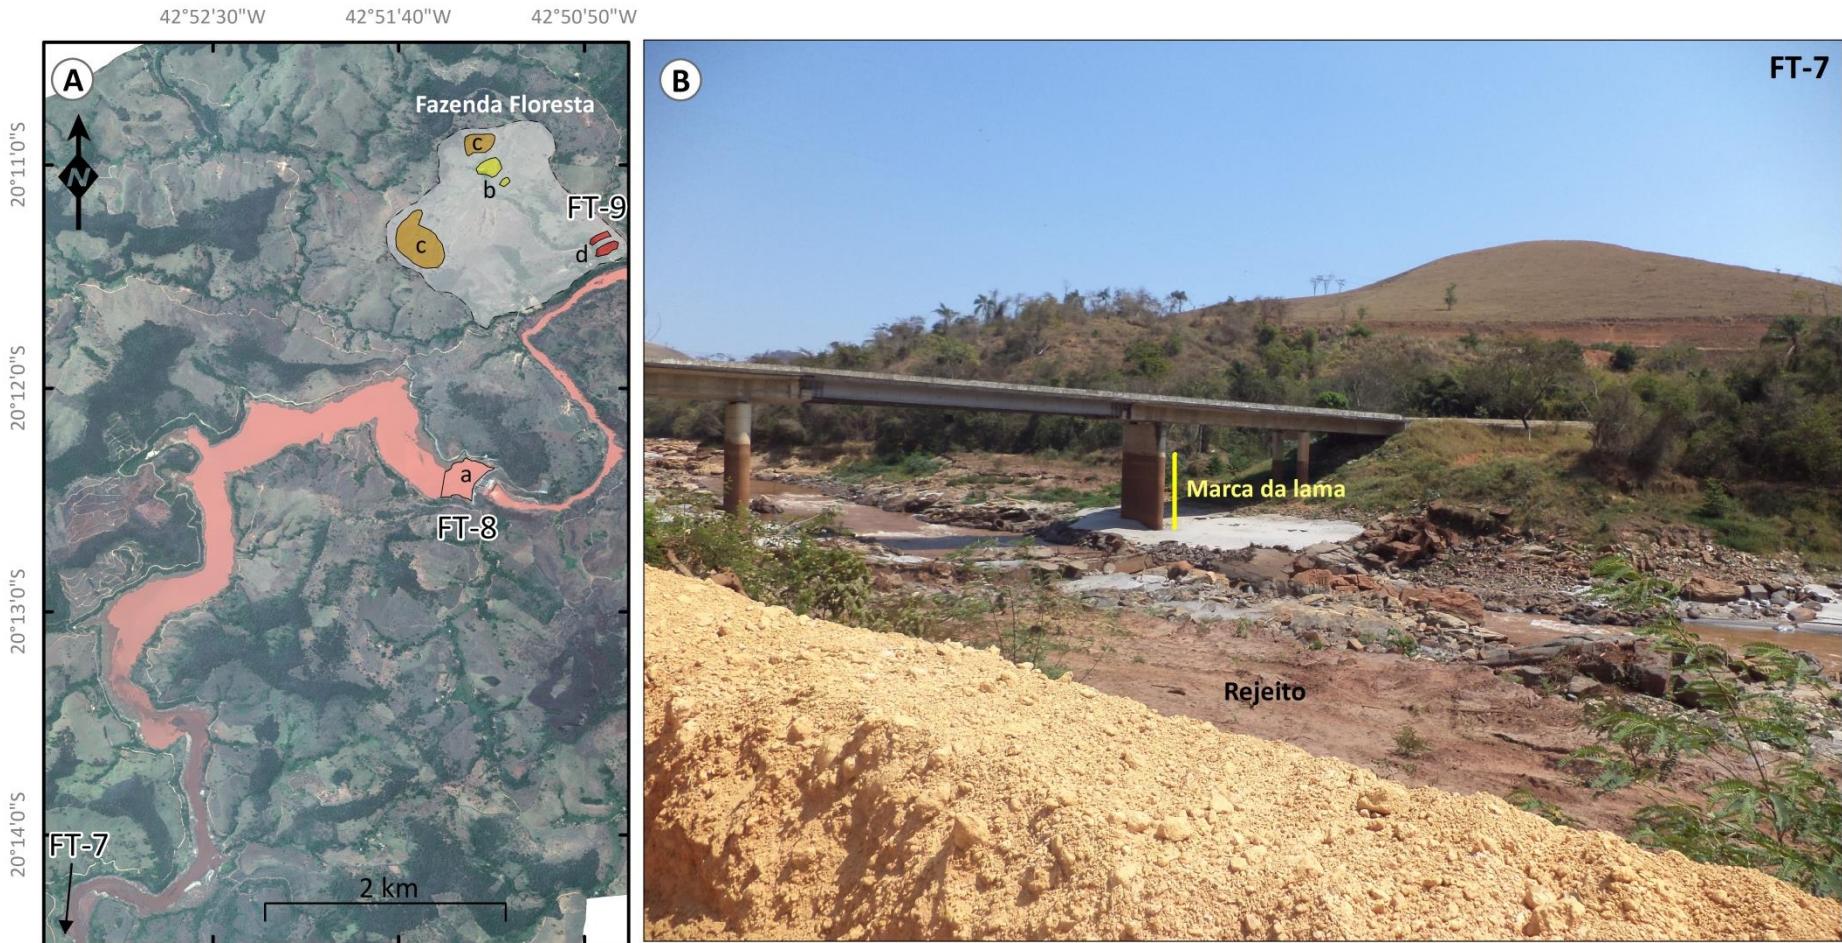
**Fig. 10.** (A) Região do reservatório da UHRN e a fazenda Floresta, vistas pela imagem de alta resolução espacial do sensor WorldView-2, numa composição colorida cor real (RGB-123), do dia 8 de abril de 2016. Na imagem nota-se que o reservatório transbordou e tem aspecto lamoso. \*a – local de dragagem do rejeito, na área prioritária de 400 m (FT-8 da Fig. 11); b – enseadeiras e sumps; c – local destinado ao empilhamento do rejeito; d – bacias construídas para o tratamento de efluente (FT-9 da Fig. 11). (B) Ponte da BR-120 sobre o rio Doce, que permite o acesso a UHRN. Detalhe para o rejeito depositado na planície de inundação do rio e a marca da lama na base da ponte. Foto FT-7 obtida em 18 de setembro de 2016 (Fonte: Acervo pessoal).

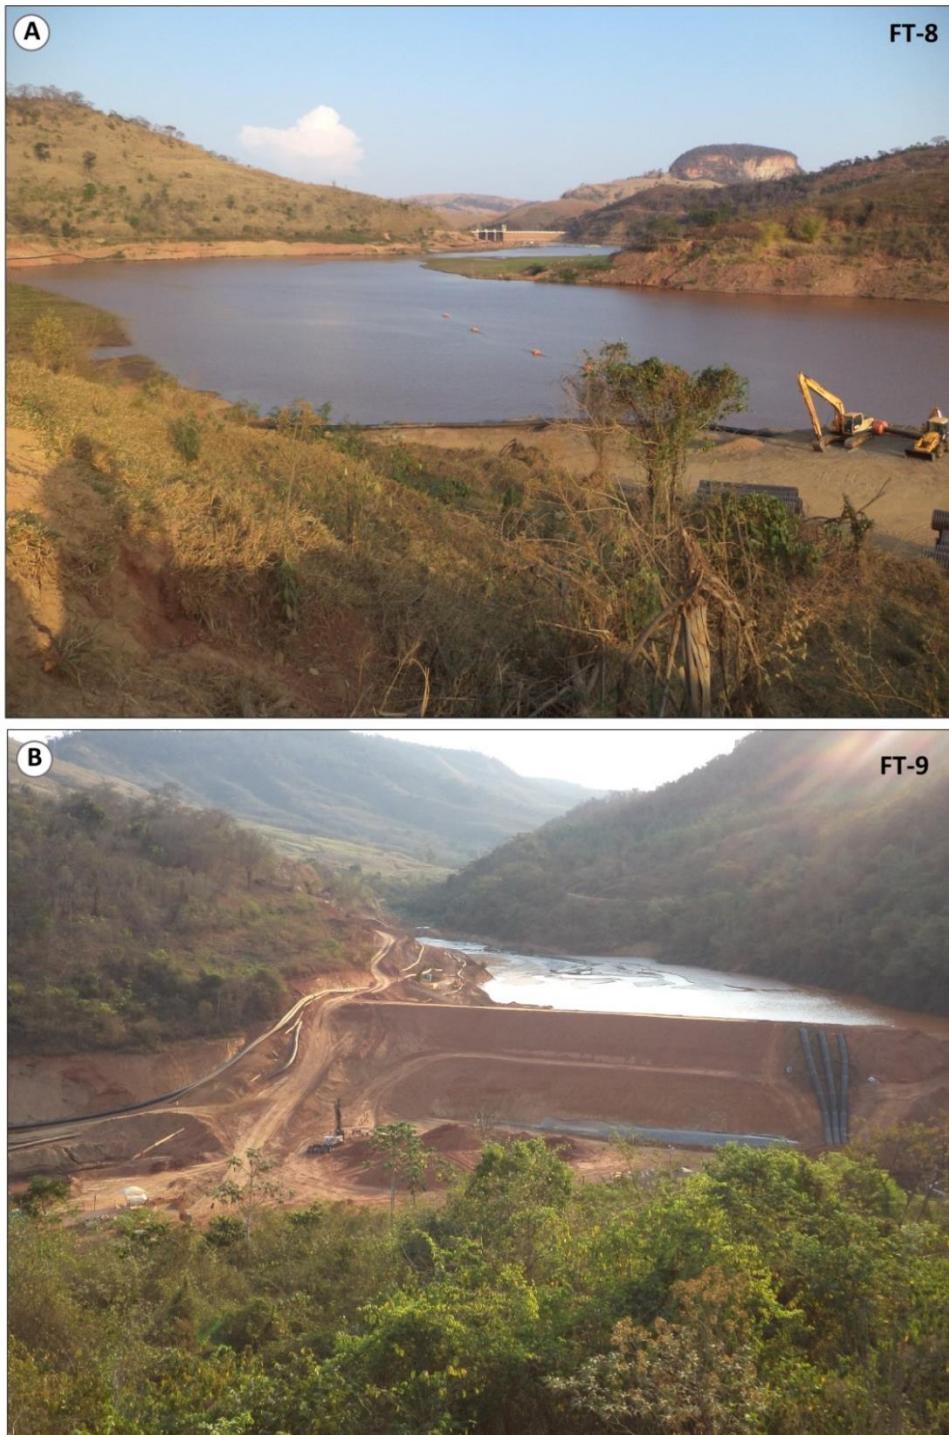
**Fig.11.** (A) Barragem da UHRN, mostrando a área considerada prioritária para retirada de rejeito. (B) Vista para um dos diques construídos na Fazenda Floresta, que compreende parte do processo de remoção do rejeito do reservatório. Fotos FT-8 e FT-9 obtidas em 18 de setembro de 2016 (Fonte: Acervo pessoal).

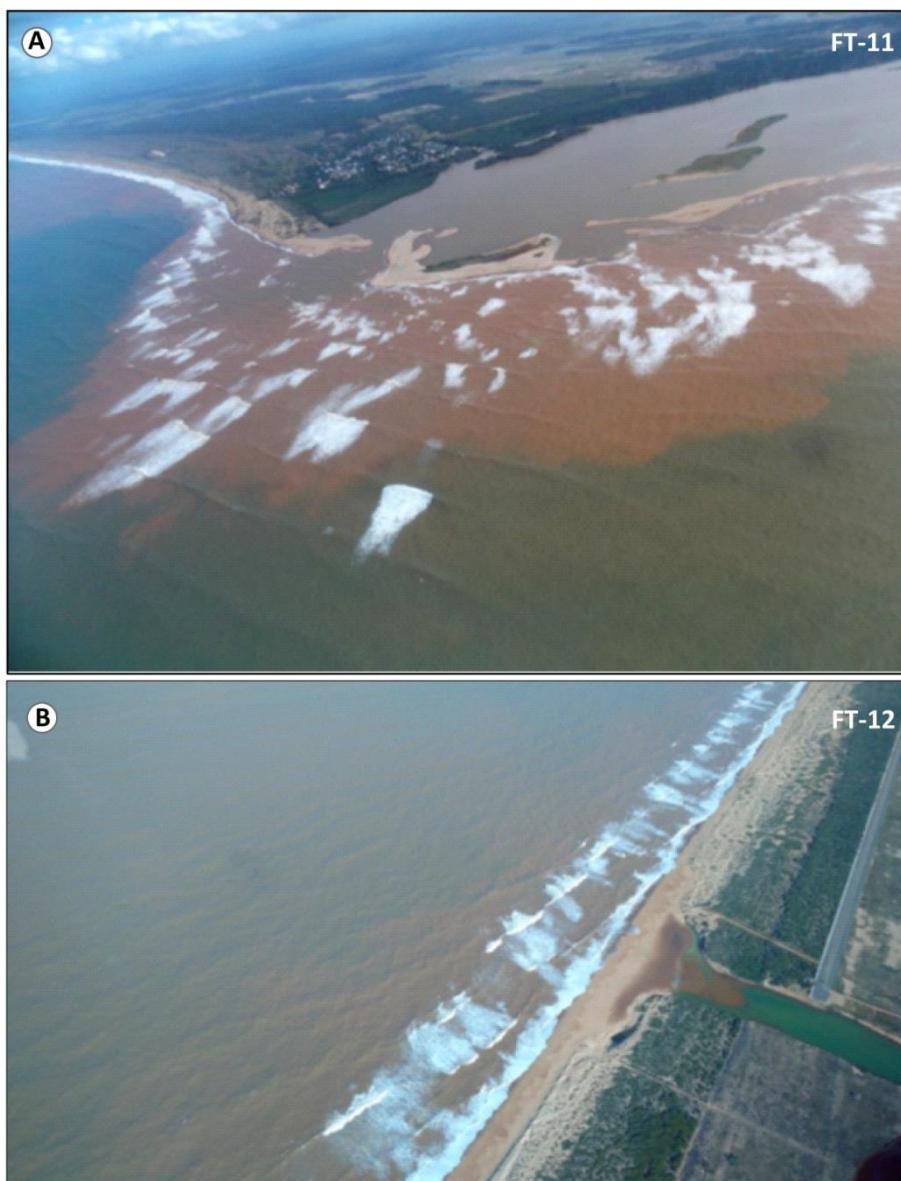
**Fig. 13.** Dispersão dos sedimentos do rio Doce na região costeira após o colapso. (A) Foto da foz do rio Doce em Linhares-ES, em maio de 2017. (B) Foto do Pontal do Ipiranga, ao norte da desembocadura do rio Doce, em setembro de 2017. Fonte: ICMBio (2017).

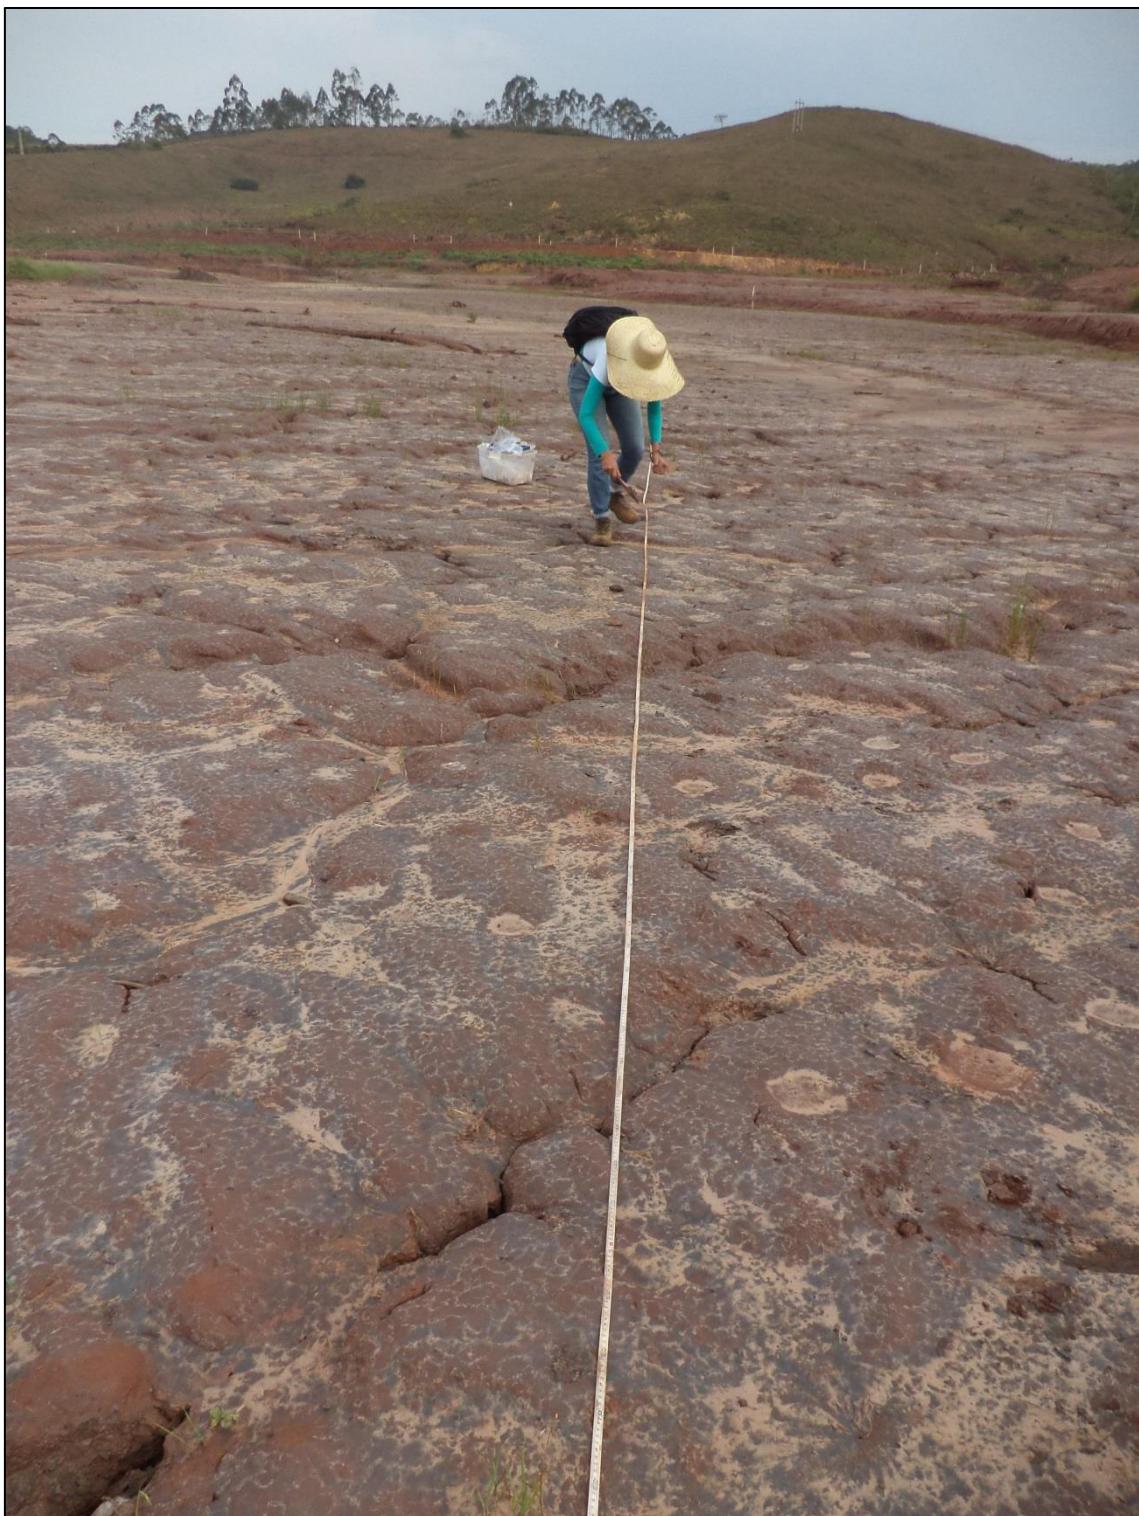
**Fig. 5.** Foto obtida em 19 de setembro de 2016. Solo encoberto pelo rejeito, bastante compactado e exibindo processos erosivos iniciais. Fonte: Acervo pessoal.

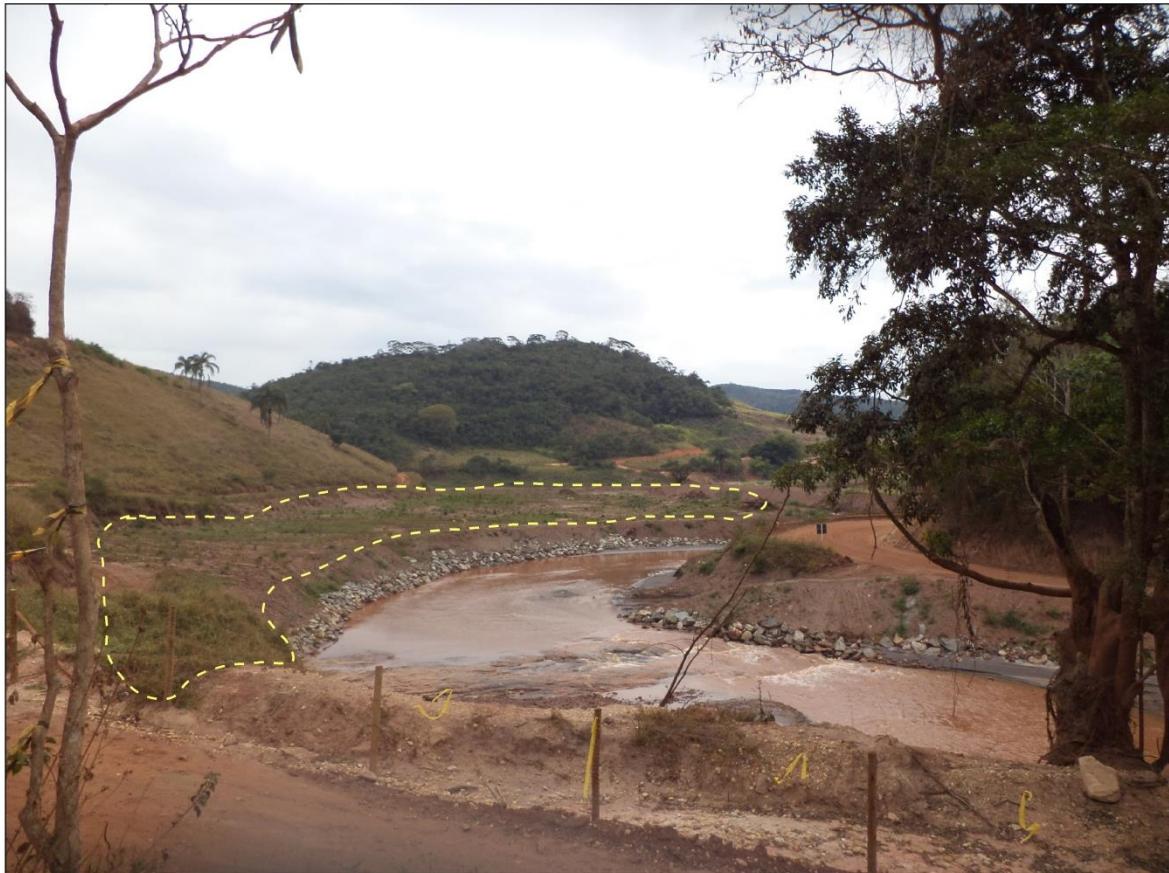
**Fig. 6.** Foto obtida em 16 de setembro de 2016. Planície de inundação do rio Gualaxo do Norte. Nesse local foi plantado uma mistura de leguminosas as margens do rio para a reparação do solo, destacado com a linha tracejada. Fonte: Acervo pessoal.

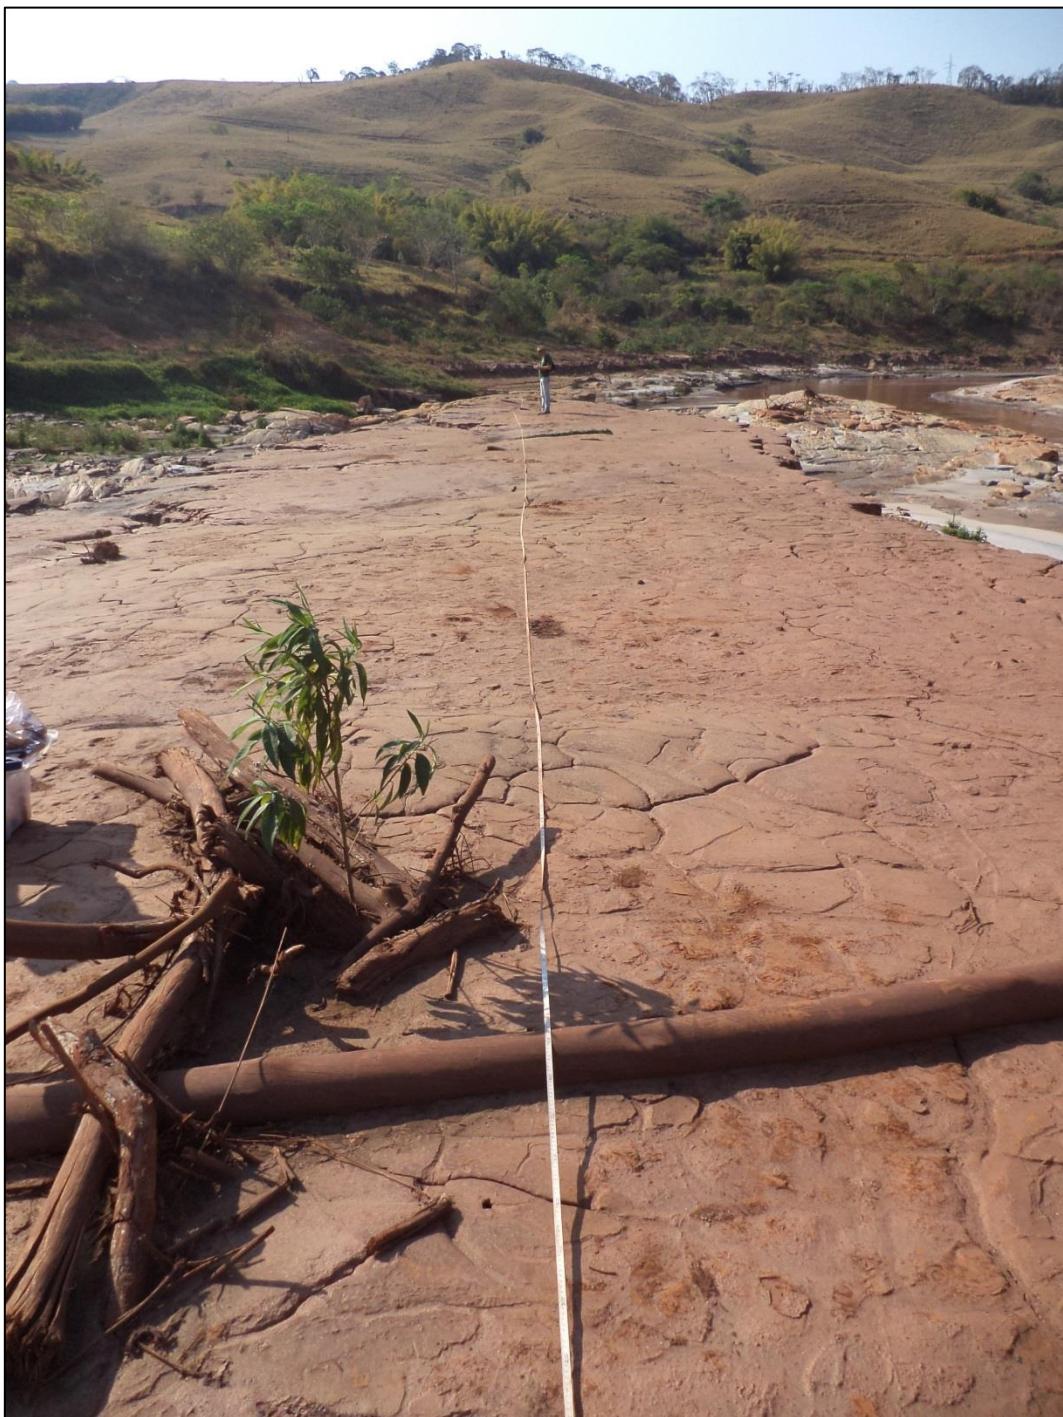
**Fig. 7.** Foto obtida em 18 de setembro de 2016. Planície de inundação do rio Doce, a montante da UHRN. Solo totalmente compactado e sem matéria orgânica e vegetação. Fonte: Acervo pessoal.

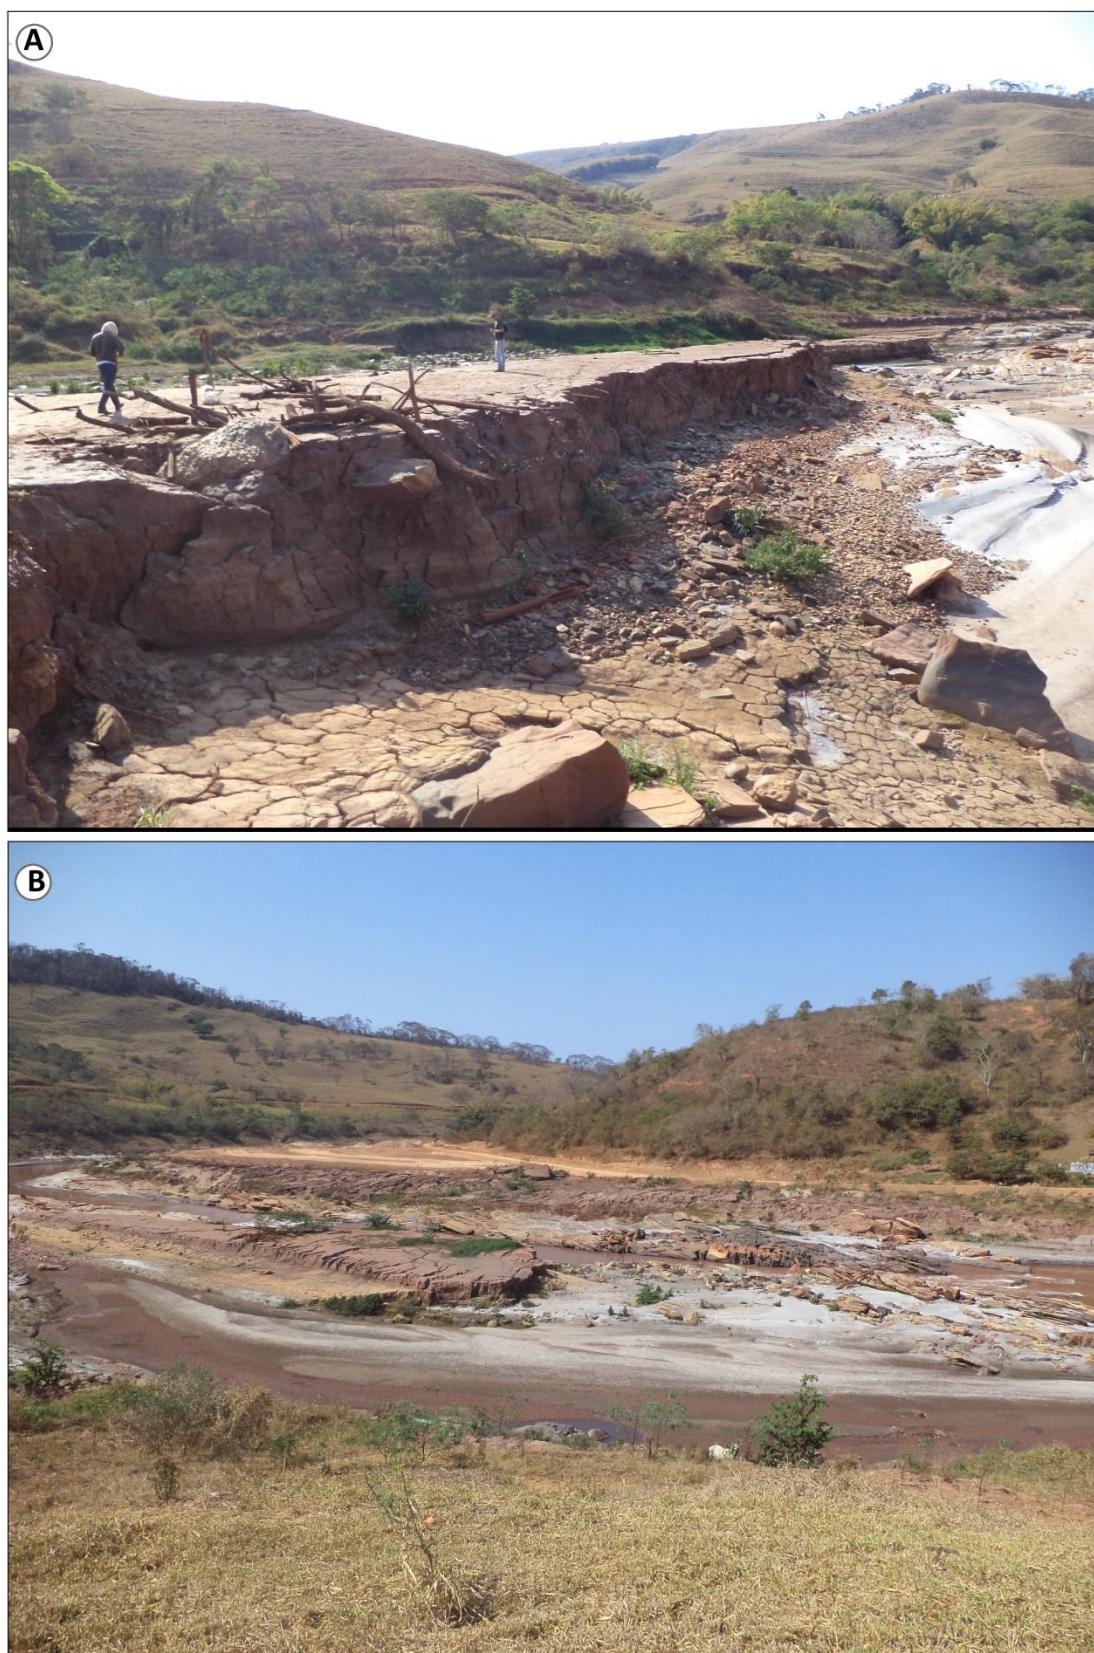
**Fig. 8.** Foto obtida em 18 de setembro de 2016. Planície de inundação do rio Doce, a montante da UHRN. (A) Solo totalmente compactado e com rachaduras. (B) Trecho do rio Doce, com baixo nível d'água e o intenso assoreamento pelo rejeito depositado as margens do rio. Fonte: Acervo pessoal.
